PRELIMINARY INVESTIGATION AND ANALYSIS OF BUILDING DAMAGE

Agel, El Salitre, San José Ixcaniche, and San José Nueva Esperanza

Guatemala

1 November 2009

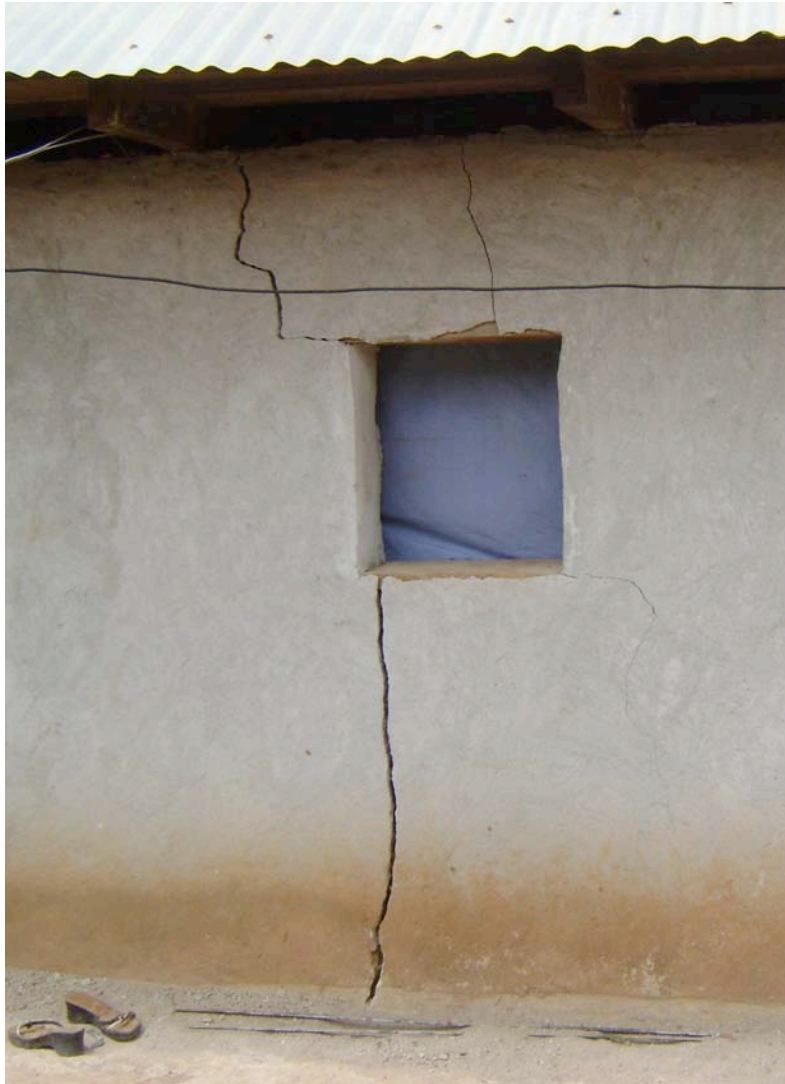
Figure 1a Vertical Wall Cracks in Adobe

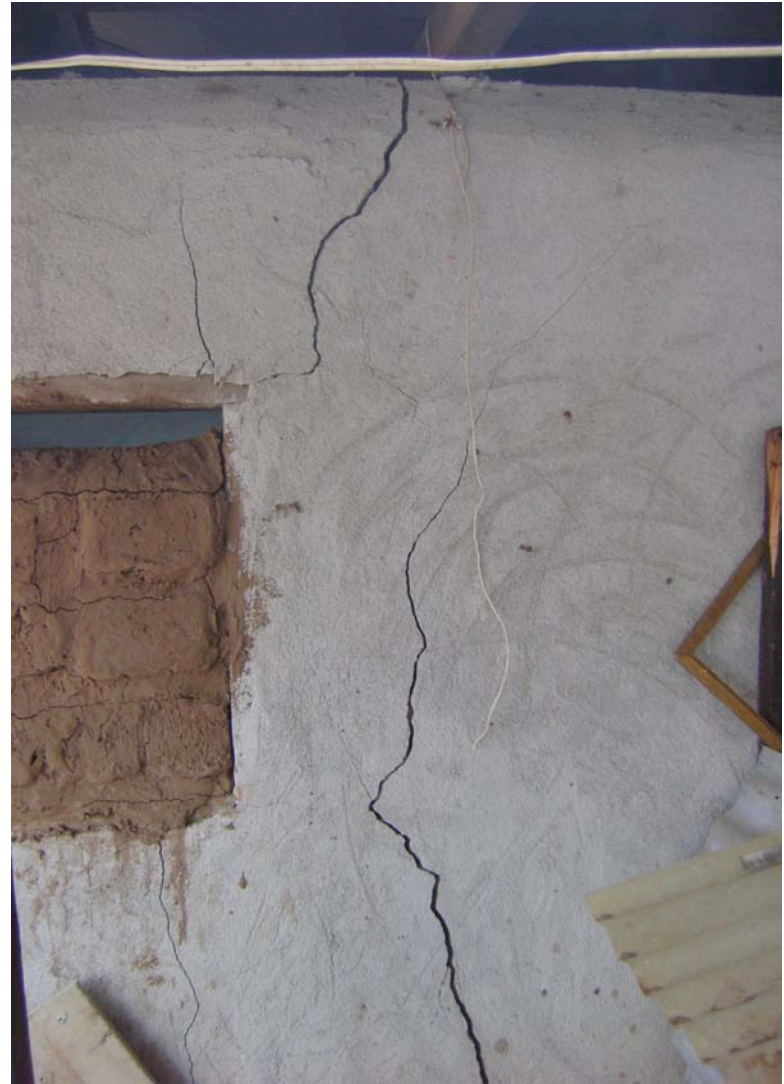
Figure 1b Vertical Wall Cracks in Adobe

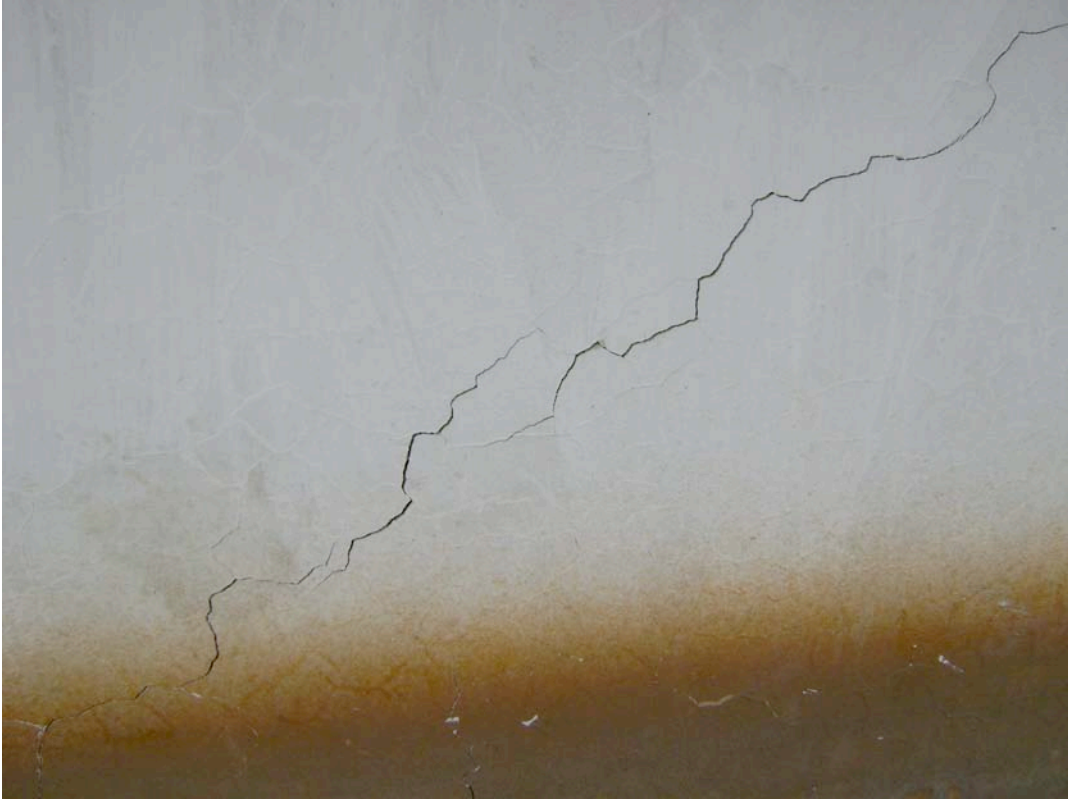
Figure 1c Incline Wall Crack in Adobe

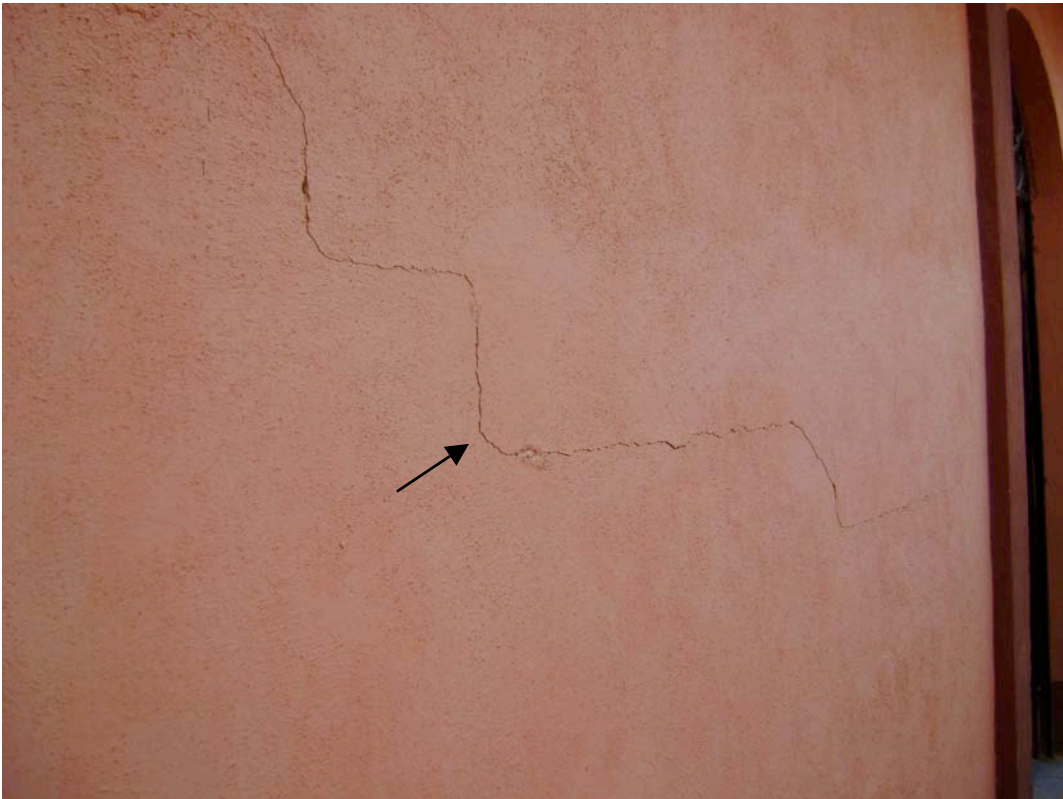
Figure 1d Crack in Concrete Block Grout

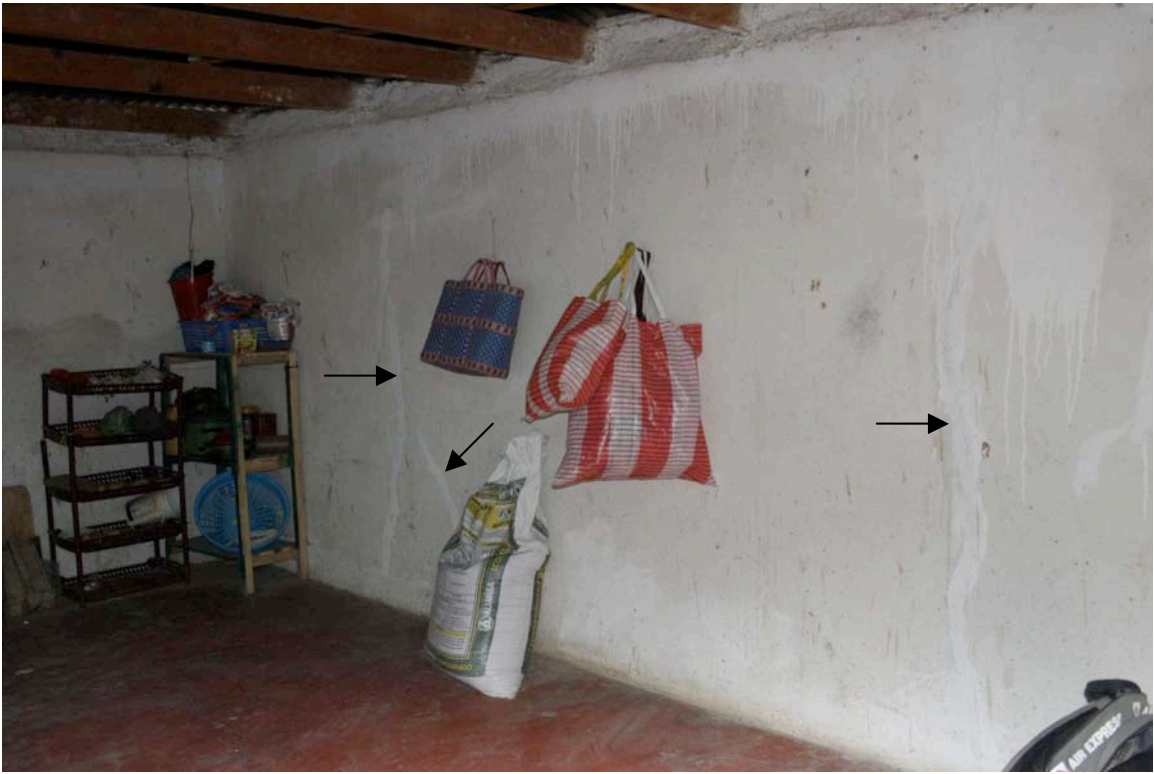
Type 1: A more or less vertical wall crack that starts (widest end) at either the top of a wall between roof beams or the base of a wall, and in the case of concrete block walls, extends stair-stepping through the mortar. There is no contiguous crack in the floor slab-on-grade.

Figure 5a Type 1 Wall Cracks (3 covered with plaster), No Slab Cracks

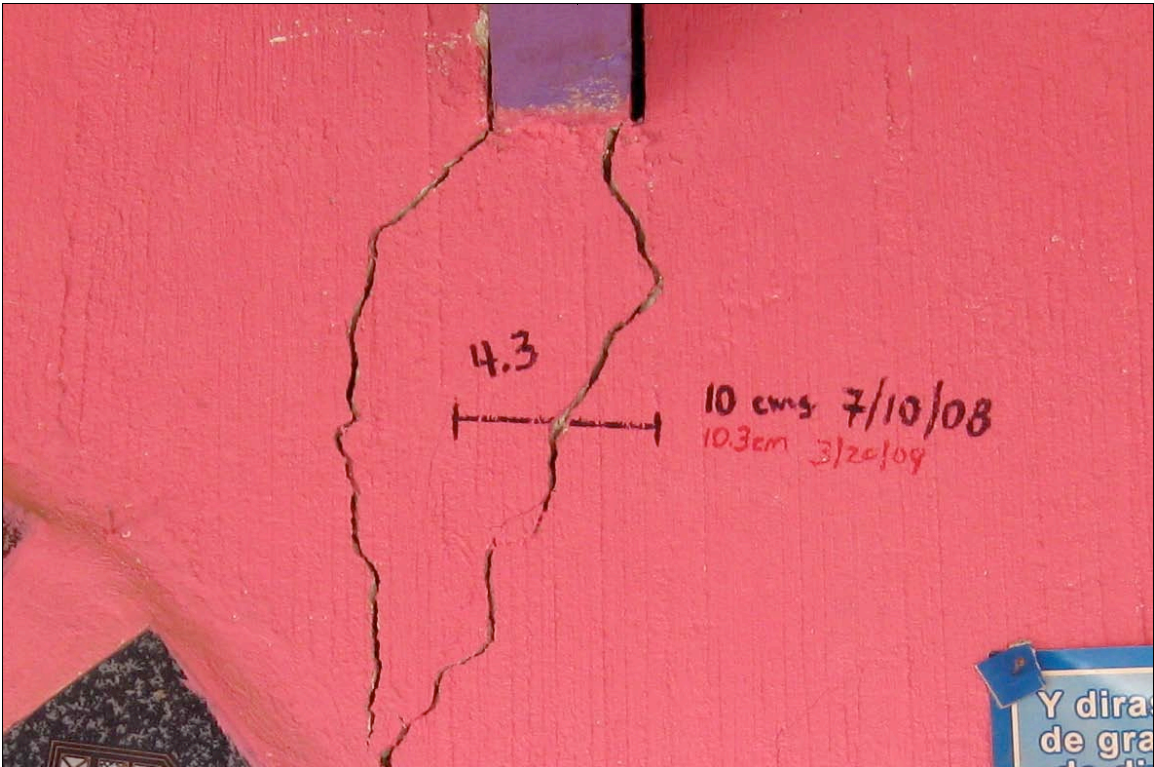
Figure 5b Type 2 Crack from Window or Door to Roof Beam

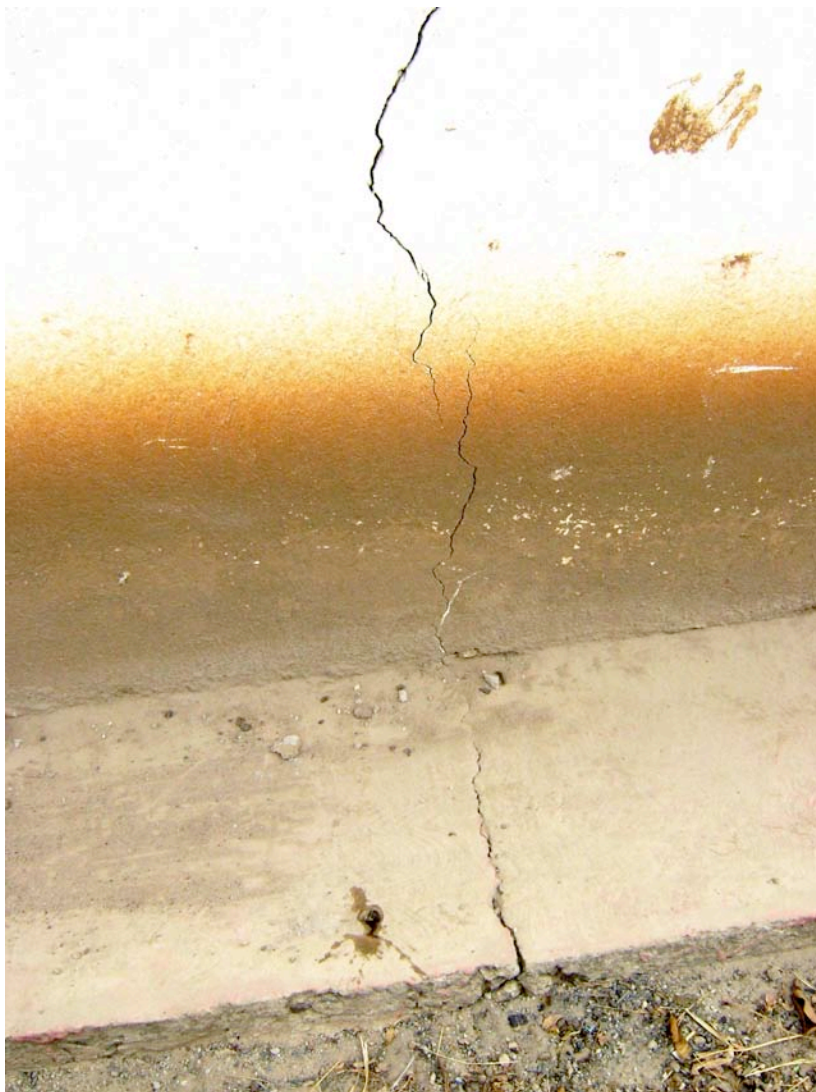
Figure 5c Type 3 Crack in Wall and Slab

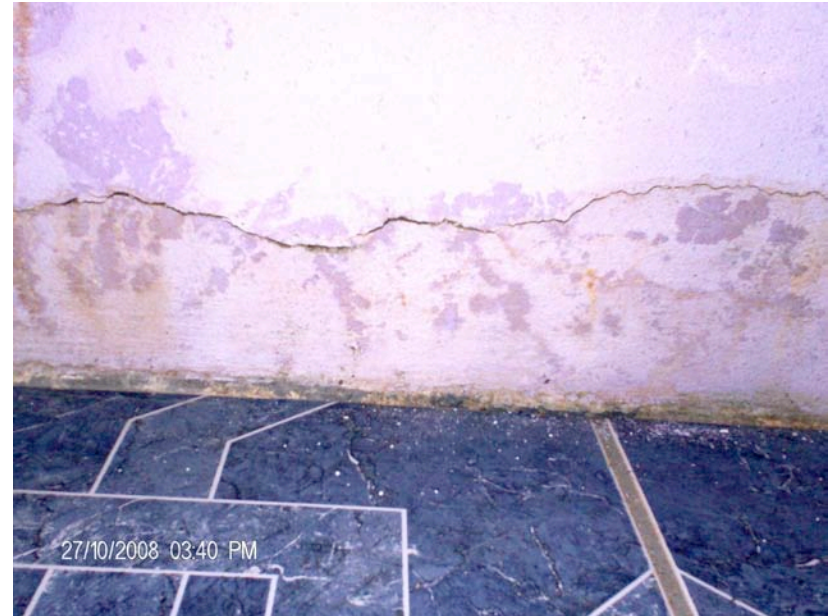
Type 4: A horizontal crack that is usually found at mid-wall in adobe or in the mortar between concrete blocks.

Figure 5d Type 4 Horizontal Crack

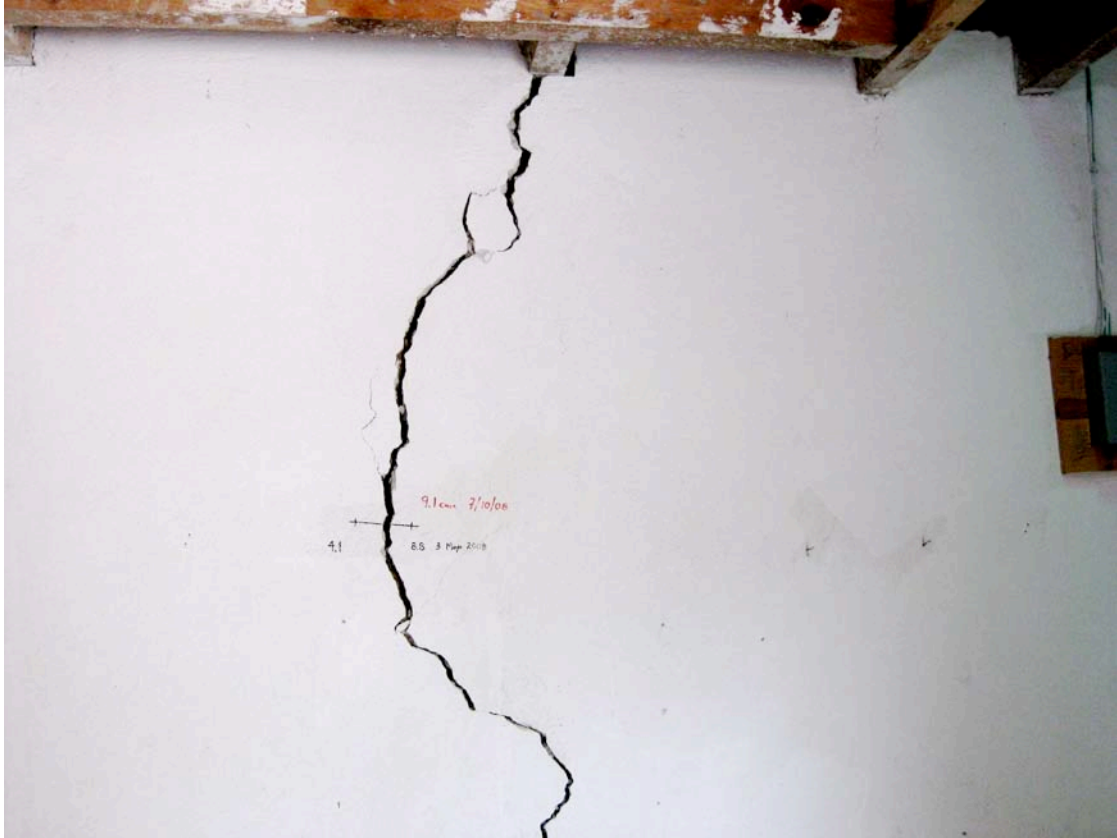
Figure 5e Type 5 Wall Crack Below Roof Beam

This type of crack occurs from excessive flexing of the wall caused by vibrations.

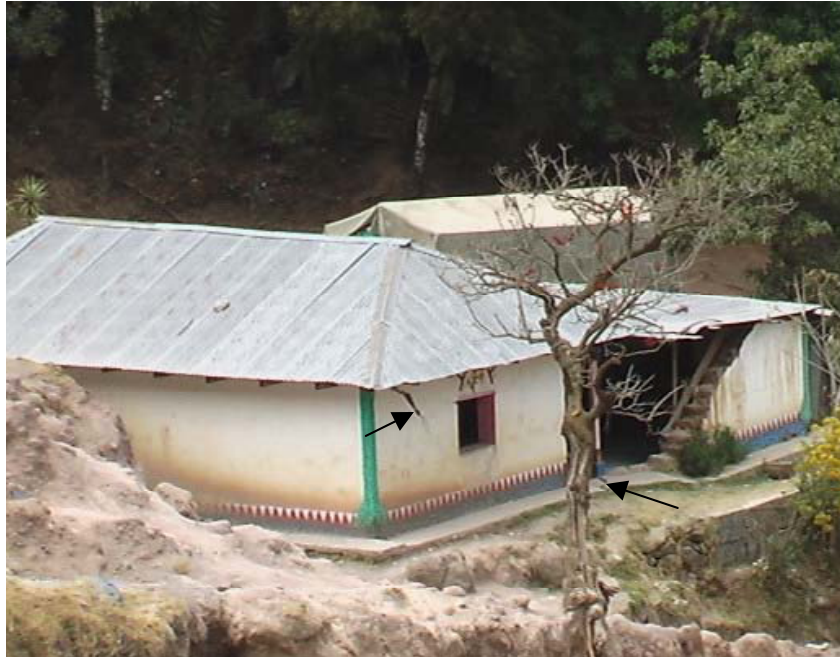
The building in Figure 9 demonstrates damage from landslides. Note the gaping hole in the wall (rubble has been removed), and large crack on the left end. In side there is extensive cracking, heaving, and subsidence of the floor. This subsidence overlies a ground fracture (indicated with arrows) and moisture that extends some 50 meters into an adjacent football field. In the surrounding small valley, the engineering team observed numerous similar fractures. This fracturing is typical of mass land movements. In addition, the team observed other extensive evidence of mass land movement including a 400-meter fracture

Figure 9a Damaged Building (note hole in wall, left arrow points to wall crack, right arrow points to fracture that extends into foreground)

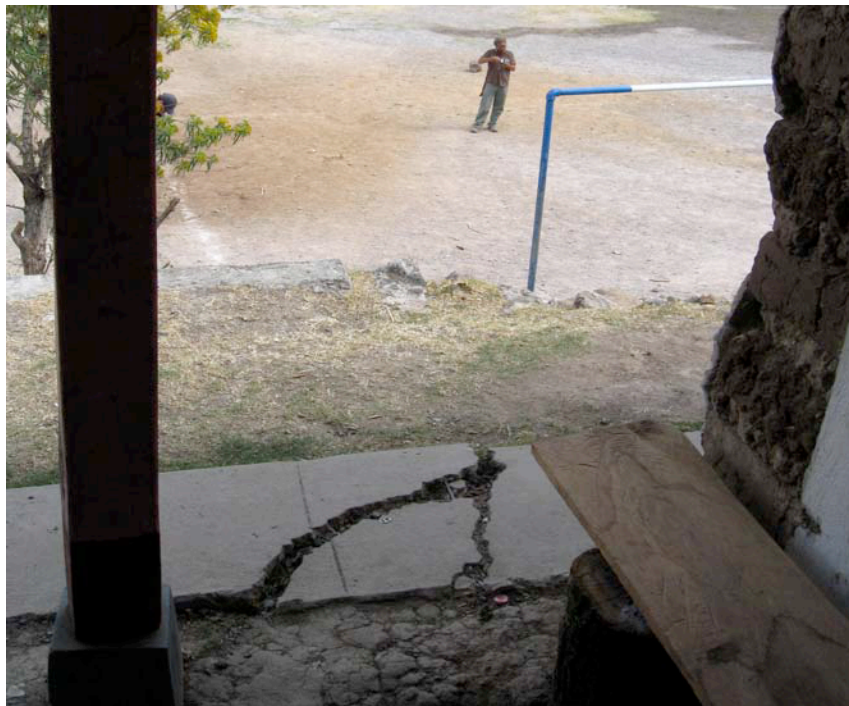
Figure 9b View From Building in Figure 9a (Fracture in foreground is same one shown in Figure 9a and it extends to person. Fracture difficult to see as it is partially filled with soil)

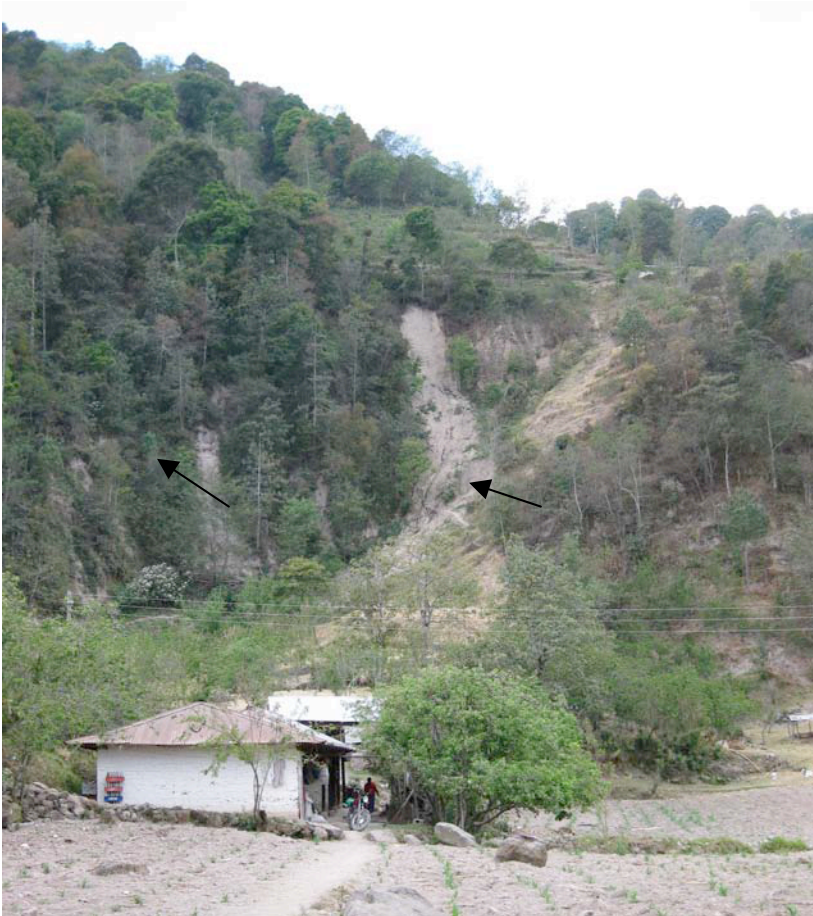
Figure 9c Escarpment (left arrow) and Recent Landslide (right arrow)

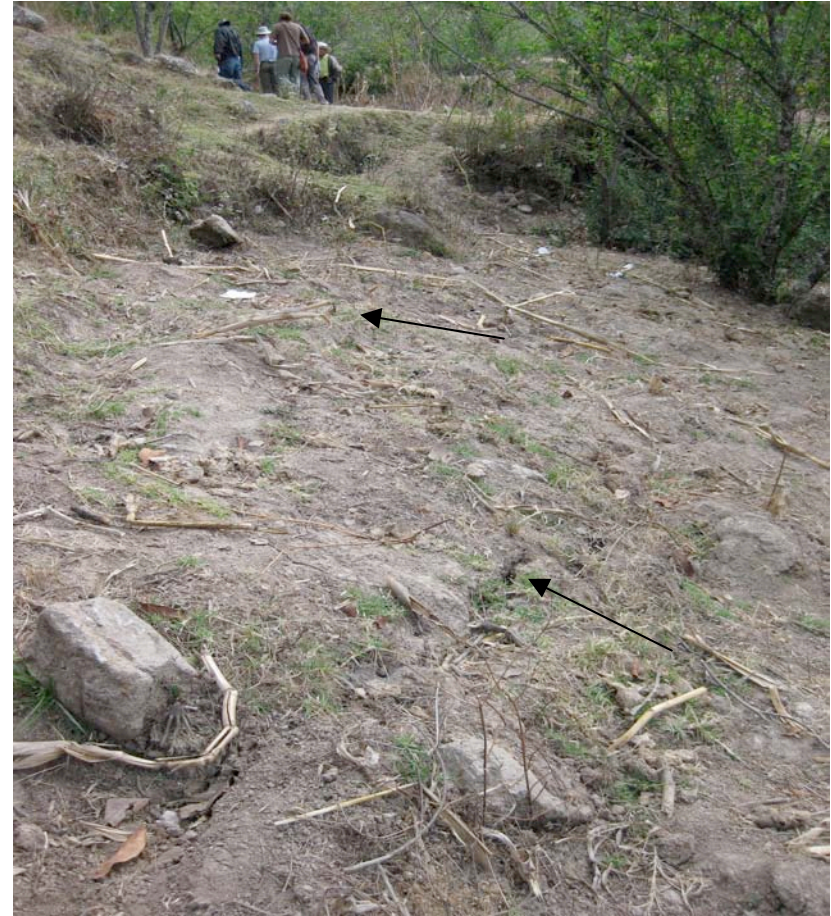
Figure 9d Arrows Show Part of a Fracture that Is 400 Meters Long
