PRELIMINARY INVESTIGATION AND ANALYSIS OF BUILDING DAMAGE

Agel, El Salitre, San José Ixcaniche, and San José Nueva Esperanza

Guatemala

1 November 2009

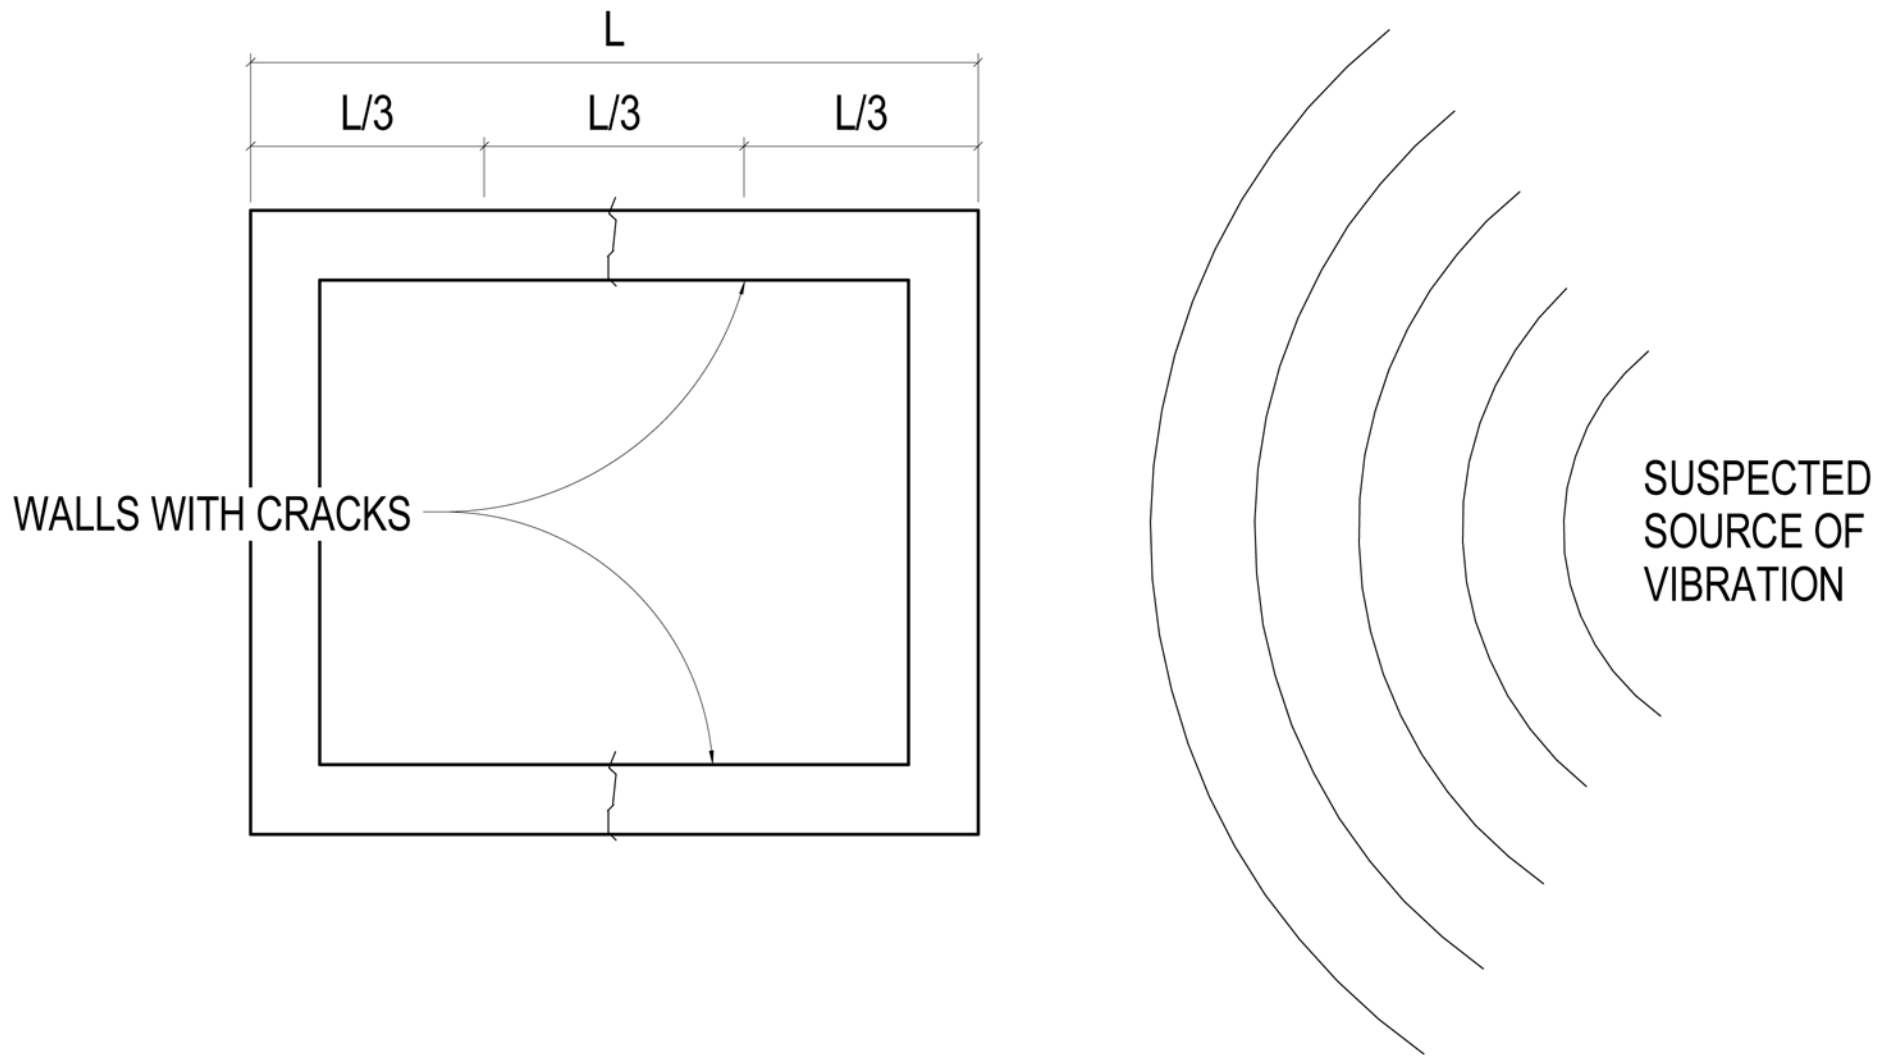
Figure 4. Crack Location Relative to Vibration Source

A particular pattern of cracks is evident in the walls of the damaged buildings, and this pattern is a clue to their cause. The cracks are more or less vertical, and usually are located within the middle third of the wall length. In addition, the most frequently cracked walls are those whose ends point toward the adjacent road and/or the mine. Figure 4 illustrates this orientation. This pattern leads to the suspicion that the source of damage is ground vibrations from heavy vehicle traffic and/or the mine blasting, and this suspicion is reinforced in the following sections of this report, which eliminate other sources of the structural damage.

In the walls observed, the middle one third of the walls is the most common location of cracks, especially if there is a nearby window or door. A wall is weakest where there are openings, and walls are weakest in their middle one third, as adjacent walls support the ends. Crack location also can be related to a cut-and-fill line underlying the building slab or foundation. Under vibration, the fill side can settle more than the cut side because the two sides cannot be compacted to the same density. Even with modern compaction machines, it is unlikely that the two sides would settle the same amount under a loading event.

Some houses are far away from the road and still damaged. They are most likely not damaged by road traffic. In general, the worst damage in these houses is in the walls perpendicular to the mine blasting.

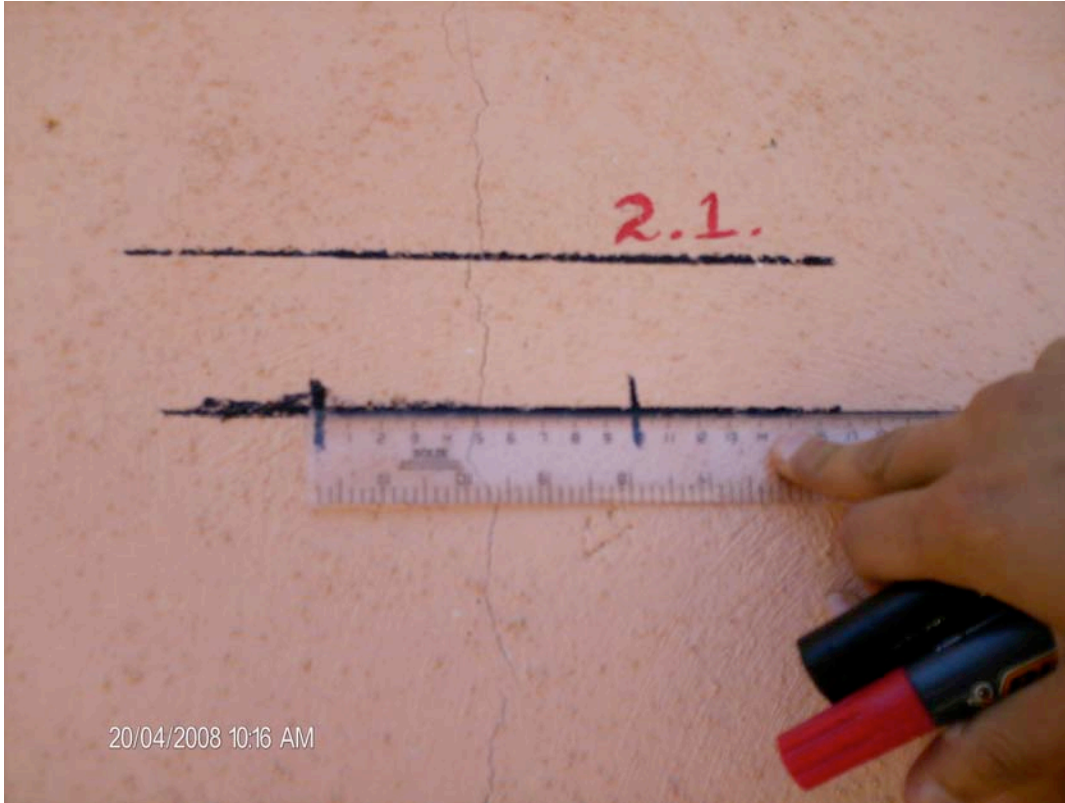
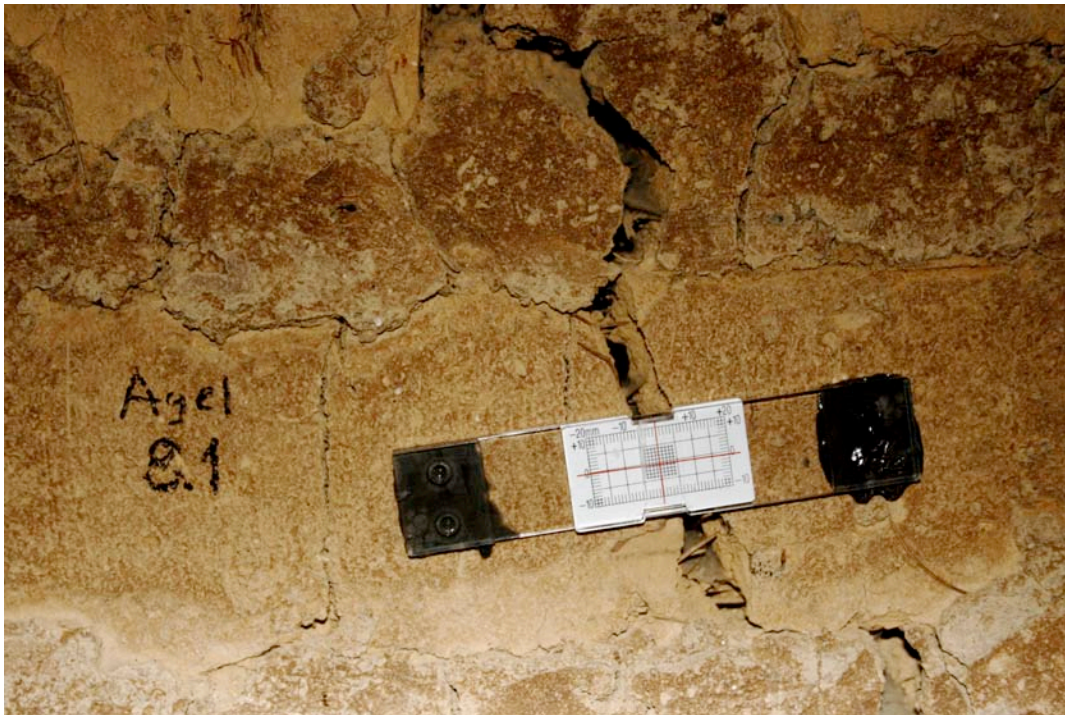
Figure 6 Methods of Crack Measurement

Thirteen cracks were monitored for displacement. The maximum displacements were small, in a range of 5 to 7 millimeters. Most of the cracks had no or trivial change in width. These results generally indicate that there are no mass land movements, subsidence or swelling of soils under the buildings, and no impacts due to changes in soil moisture from the wet and dry seasons. The one exception could be crack AG 7.1, which was stable from the beginning to near the end of the wet season, narrowed 7 millimeters at the end of the wet season,

Figure 6a Measure Crack Width on Upper Line and Measure Width of Tick Marks on Lower Line

Figure 6b Crack Gauge

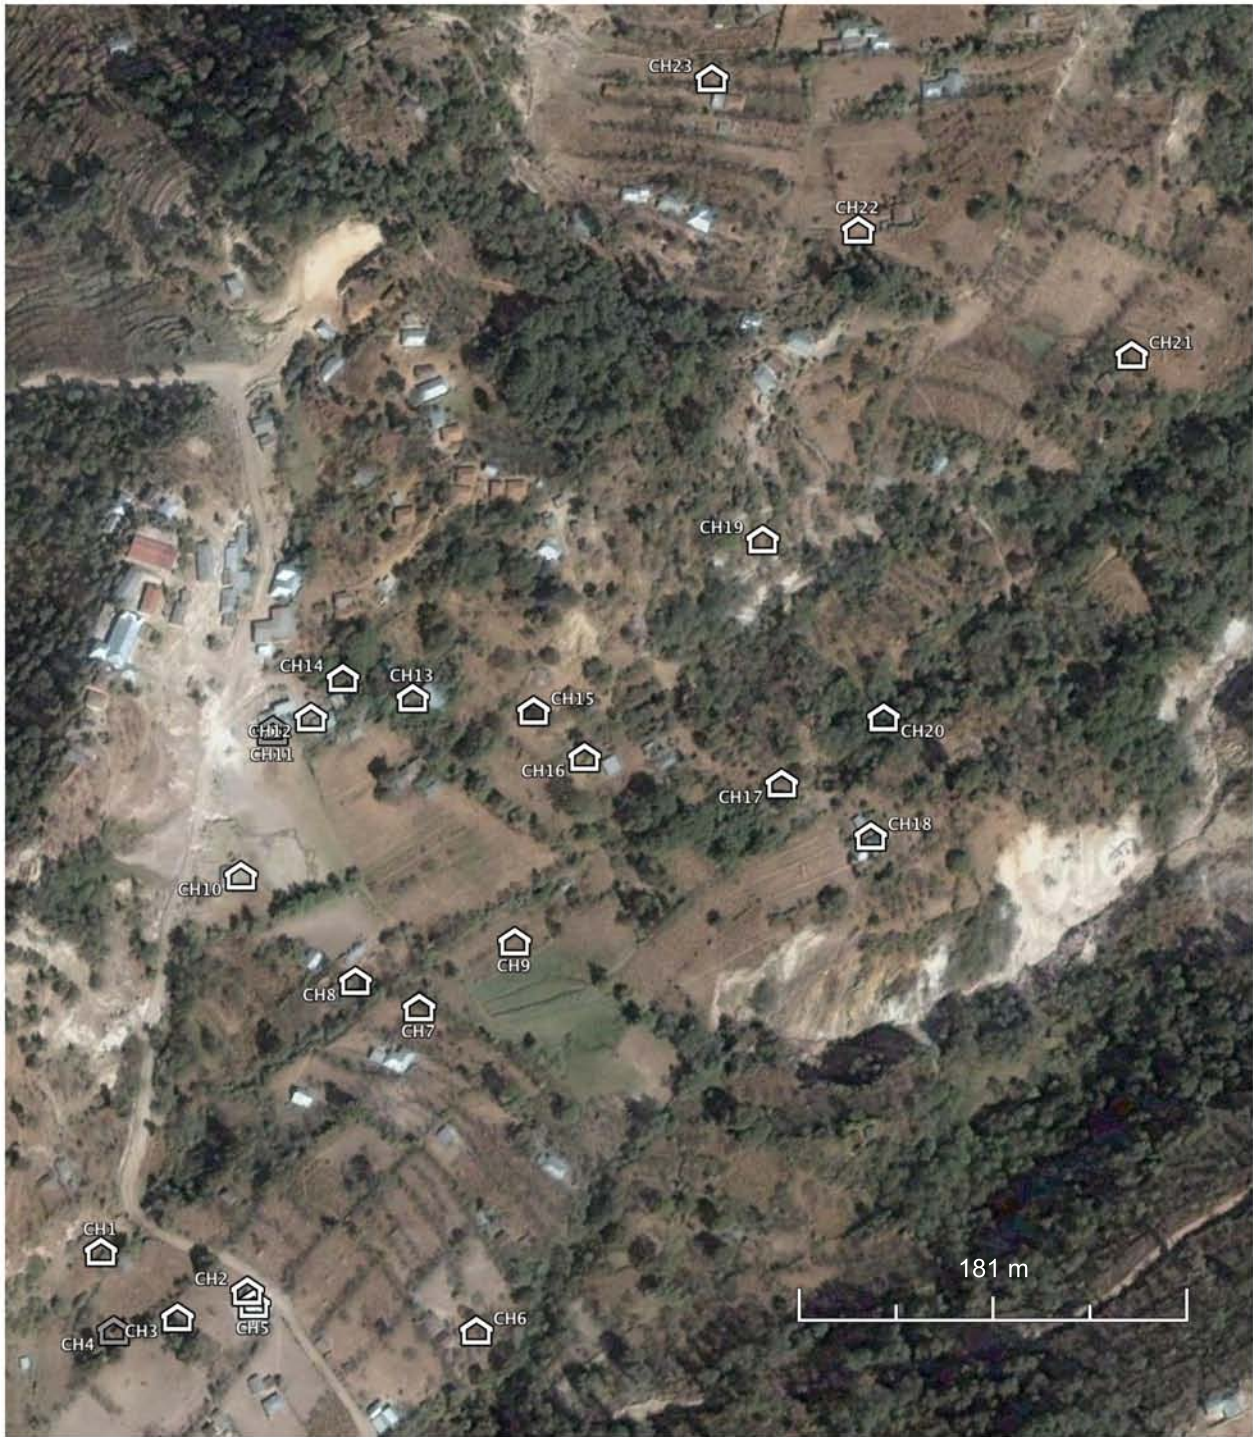
Figure 8. Map of Buildings Observed in Chininguitz. © Google Earth and Digital Globe.

There is considerable building damage in Chininguitz, but most of this damage is concentrated in a small valley, shown in Figure 8. The damage in Chininguitz differs from the damage seen in the villages surrounding the Marlin mine. It is the result of mass land movements. In Figure 8, the white area is a landslide scarp and the broad area of lighter colored land enlarging in a trend from the lower left toward upper right is the unstable and moving ground. There are extensive fractures in the area that extend several hundred meters including one just to the left of building CH 6 and another in the lower right corner of the image.

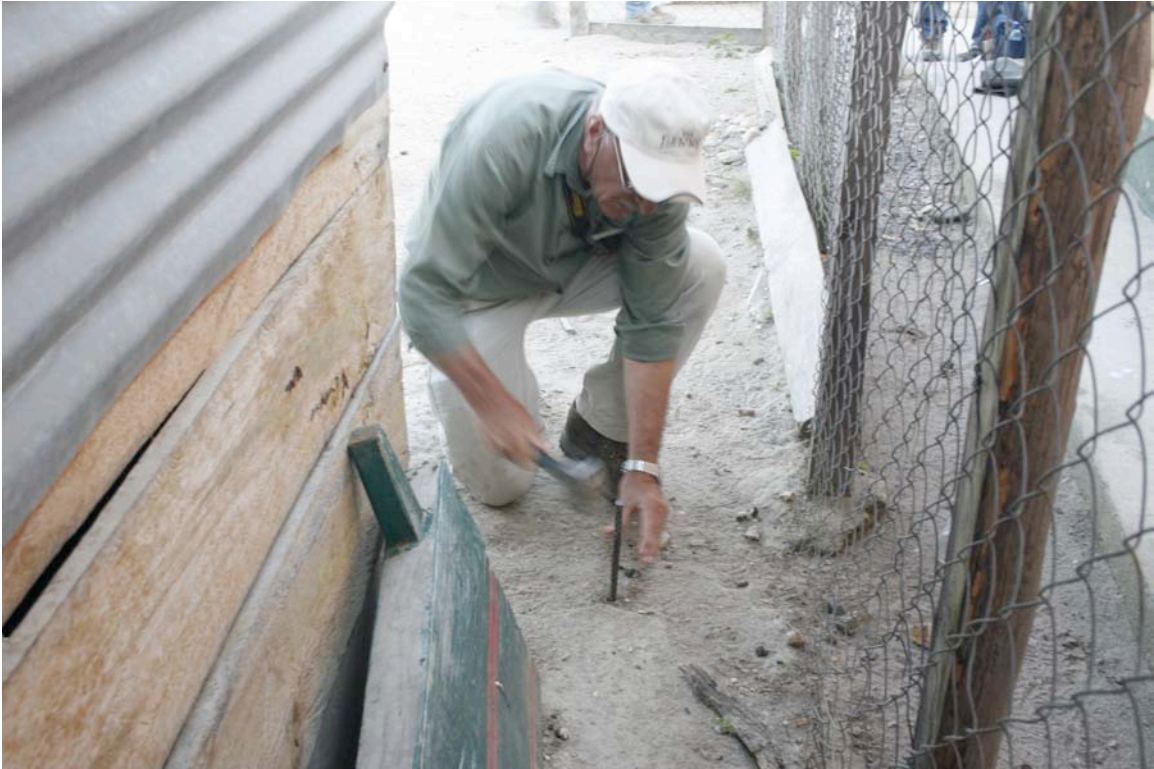
Figure 11 Field Density Test

In addition to the lab-testing, a simplified field density test determined the relative density of the soil. The test consists of hammering a 10-millimeter diameter rebar into the ground with a 2.5-kilogram hammer. See Figure 11. The number of blows required to penetrate a given depth was recorded, see last column of Table 4. The test does not give quantitative results, but does generally indicate the relative soil density at the various locations.

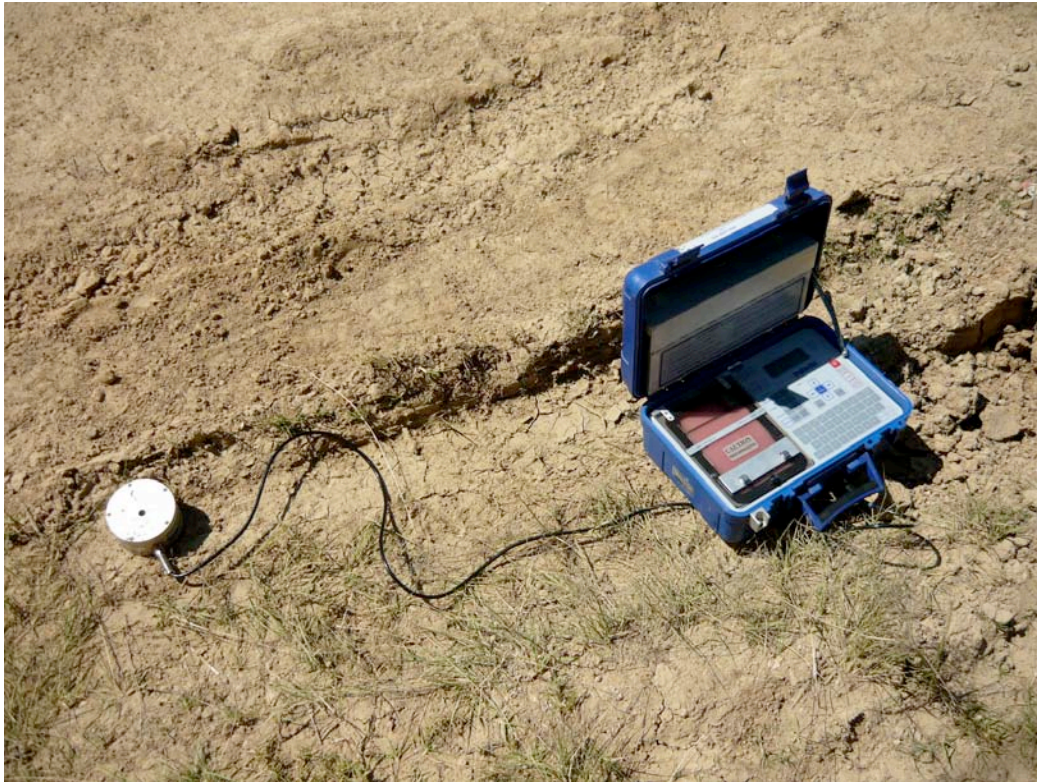
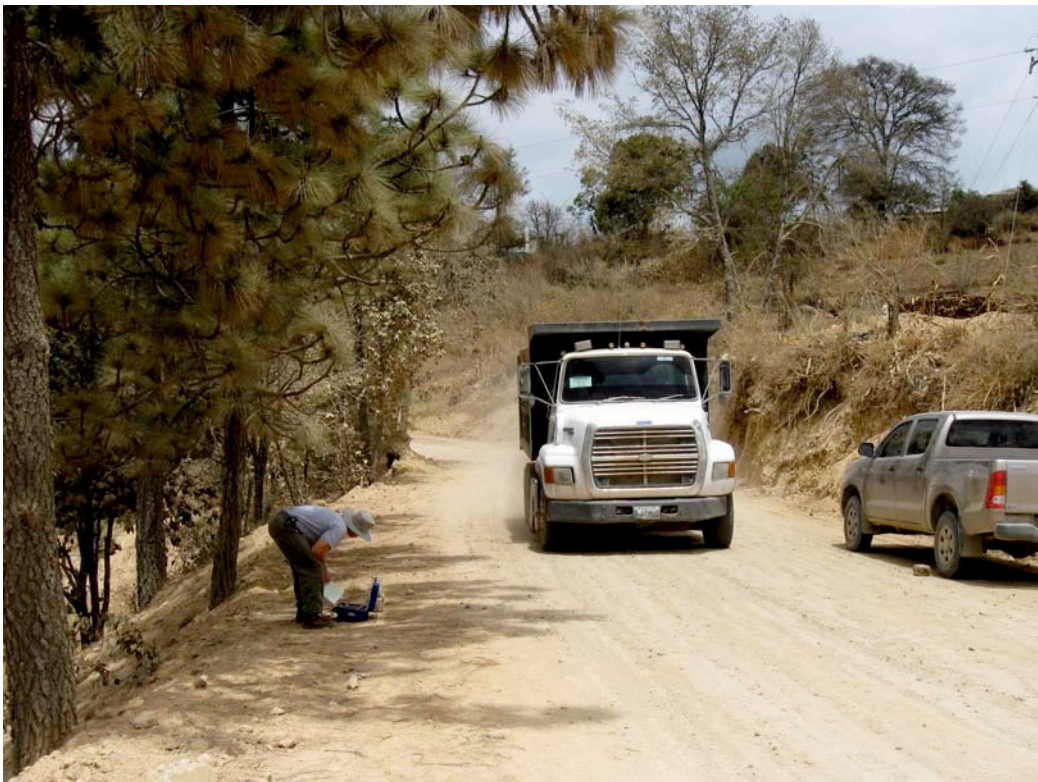
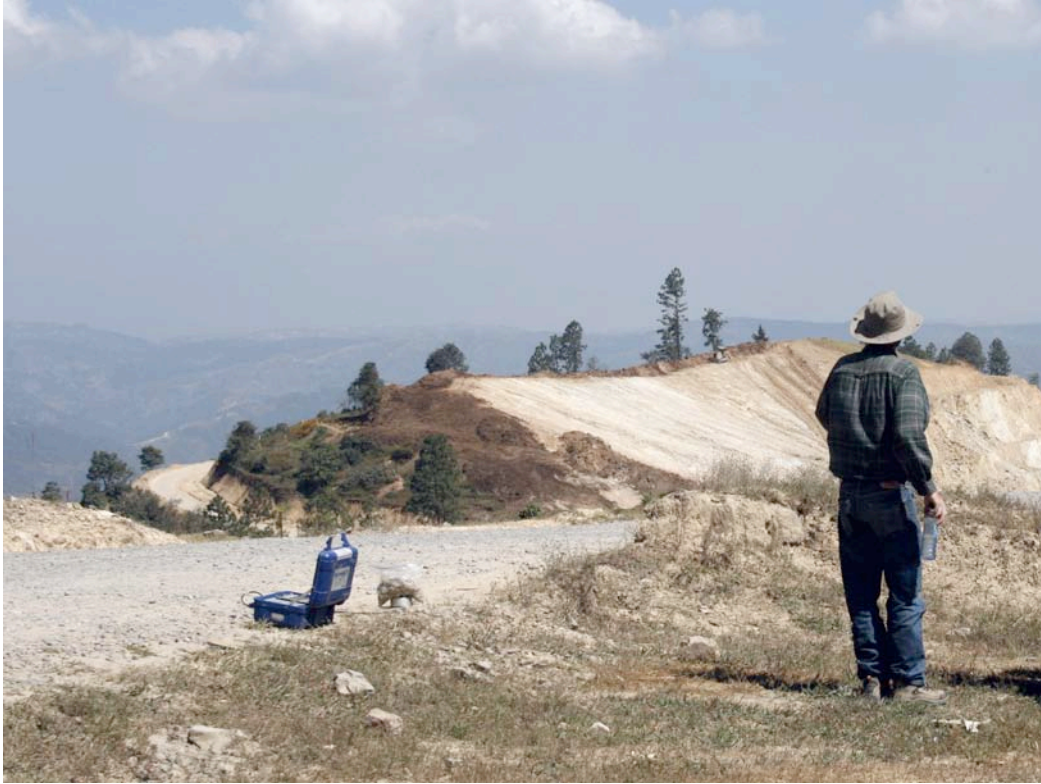
Figure 12 Vibration Monitoring

Vehicle vibrations were monitored using an unloaded and loaded Ford three-axle dump truck model Aeromax L9000; as shown in Figure 12. The empty weight of the truck is 13600 kilograms, and the maximum capacity of the truck loaded is approximately 27300 kilograms. This truck is smaller than the largest trucks seen on the road, which were fuel tank trucks. The truck drove past the Blastmate III at various speeds up to 50 kilometers per hour.

The peak particle velocities for the tests are summarized in Table 6, and the Blastmate III detailed results are included in Appendix H. For the unloaded truck moving at a speed of 10 to 30 kilometers per hour, the peak particle velocity remains within a range from 0.238 to 0.349 millimeters per second. The peak particle velocity increases to 0.476 millimeters per second at 40 kilometers per hour, and then more than doubles to 1.16 millimeters per second at 50 kilometers per hour. For the loaded truck at 30 kilometers per hour, vibrations are a maximum peak particle velocity of 0.540 millimeters per second. The loaded truck increases the vibrations 55 percent over the unloaded truck. Road construction underway in Agel prevented additional testing of the loaded truck.
